**DEPARTMENT OF TRANSPORTATION**

Contract #: 04-0120F4Cty: SF/ALA Rte: 80 PM: 13.2/13.9File #: 1.28**WELDING INSPECTION REPORT****Resident Engineer:** Casey, William**Address:** 333 Burma Road**City:** Oakland, CA 94607**Report No:** WIR-029898**Date Inspected:** 30-Jul-2013**Project Name:** SAS Superstructure**OSM Arrival Time:** 700**Prime Contractor:** American Bridge/Fluor Enterprises, a JV**OSM Departure Time:** 1730**Contractor:** American Bridge/Fluor Enterprises, a JV**Location:** Job Site**CWI Name:** Jesus Cayabyab, Bernie Docena**CWI Present:** Yes No**Inspected CWI report:** Yes No N/A**Rod Oven in Use:** Yes No N/A**Electrode to specification:** Yes No N/A**Weld Procedures Followed:** Yes No N/A**Qualified Welders:** Yes No N/A**Verified Joint Fit-up:** Yes No N/A**Approved Drawings:** Yes No N/A**Approved WPS:** Yes No N/A**Delayed / Cancelled:** Yes No N/A**Bridge No:** 34-0006**Component:** SAS Tower**Summary of Items Observed:**

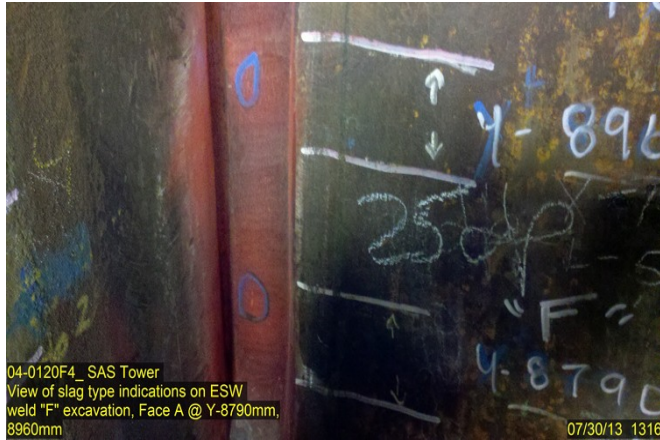
The QA Inspector was later present to observe ABF welder Simon Ma performing exploratory excavation of ESW “F” Face A @ Y-8790mm, 8960mm to verify indications observed during Ultrasonic Testing pulse/echo & pitch/catch. Mr. Ma was performing grinding on the excavation. ABF QC Inspector Jesse Cayayab stated that Mr. Ma will excavate every 3mm deep and allow QC/QA to inspect the excavation. Location of the repair is as follows:

Weld excavated at 25mm- Linear indication (slag) @8840, X=-15, L= 4mm remains

Weld excavated at 25mm- Linear indication (slag) @8790, X=-15, L= 4mm remains

Weld excavated at 25mm- Linear indication (slag) @8960, X=-15, L= 5mm remains

Excavation Length Y=8680mm~9090mm (Excavation work in progress to be continued on the next work shift)  
After grinding to bright metal the QC Inspector performed MT testing of the excavation to inspect for weld discontinuities at each hold point. See TL-6028 for additional details on items inspected on this date.
